EVALUATION OF HEAVY METALS CONTAMINATION AT CFAD DUNDURN RESULTING FROM SMALL-ARMS AMMUNITION INCINERATION

Defence Research Establishment Valcartier

Technical Report

DREV TR-2001-127

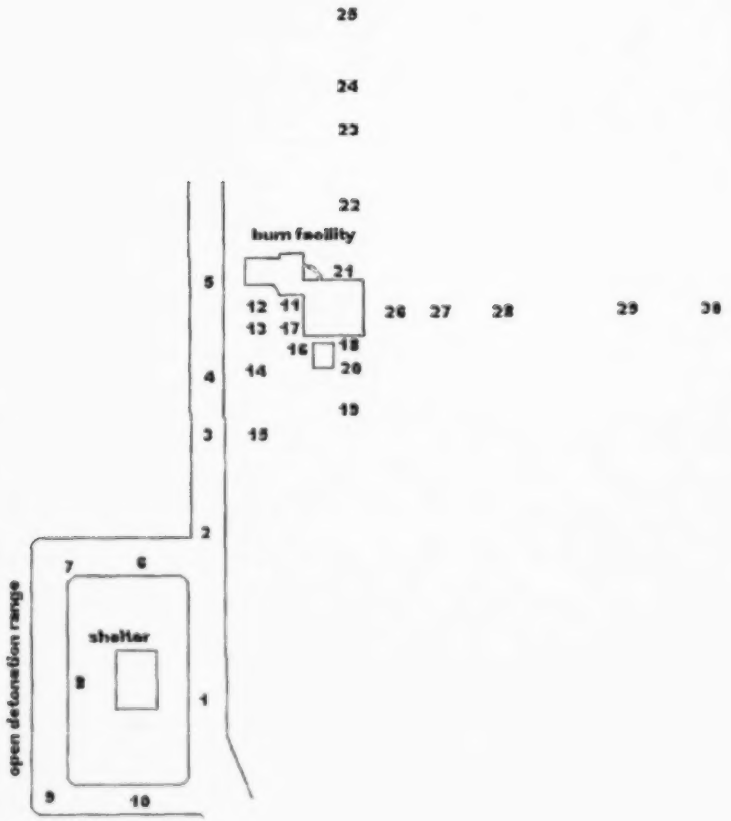
Figure 3. Soil sample locations

Soils samples were taken using two different compositing techniques. The locations of the soil samples are shown in Fig 3. Numbers correspond to the soil sample number.

The soil samples showed some elevated readings. All results may be viewed in Annex 2. The sandblast residues from the furnace, samples S-39A and S-39B were heavily contaminated, with lead concentrations an order of magnitude above acceptable values for industrial sites. These samples also had barium and copper levels three orders of magnitude above acceptable levels and cadmium concentrations 4 times higher than acceptable. Other elements were also found in elevated concentrations, such as strontium, phosphorus and zinc. Considering the nature of the samples, these results are not surprising.

Fortunately, these results appear relatively localized. Soil samples taken from residential areas both on and off the base (S-31 and S-32) showed lead concentrations comfortably within the typical normal range of soils of 2-300 mg/kg. Furthermore, measured concentrations of lead decreased rapidly with increasing distance from the burn facility. The difference in lead levels in samples S-12 to S-15 or in samples S-26 to S-29 demonstrate this clearly.

It is also recommended that further testing be done to determine the precise extent of the lead contamination to the surrounding soil, and that this soil be treated or disposed of accordingly. The shelter and burn facility buildings must be thoroughly cleaned and painted to ensure the safety of workers.

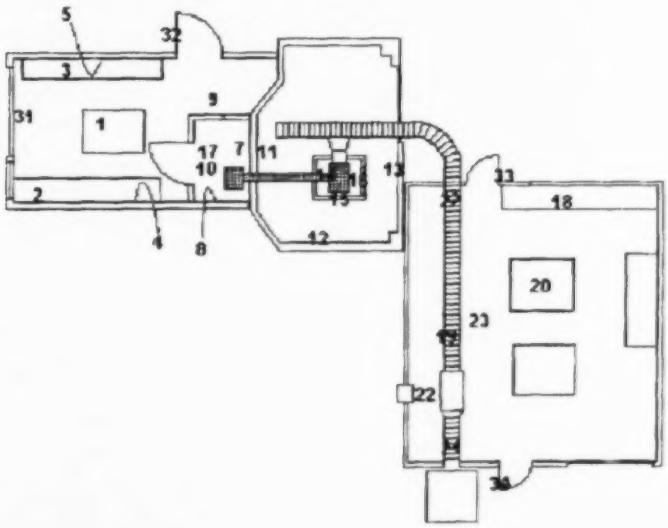
Figure 5. Burn facility swab locations

Fresh swabs were used once the old ones were saturated with contaminant. Swabs were stored in sealed glass jars until analysis. Fig. 5 and 6 show the 35 locations where swab samples were taken at the burn facility and shelter respectively.

The swab samples were a cause for serious concern. Several samples taken in work areas showed astronomically high lead concentrations. The maximum allowable concentration of lead in a 900 cm^2 area is 40 µg on floors or 250 µg on walls or windowsills according to the most recent standards published by the US EPA. Twenty-seven of the 35 swab samples were above this limit. Complete results may be viewed in Annex 3. Seven of these, FR 10, FR-11, FR-17, FR-18, FR-21 and FR-22, were several orders of magnitude higher than the acceptable limits as put forth by both the EPA and the Quebec ministry of the environment (see Table 3). These samples were taken inside the buildings of the burn facility, which were used routinely by personnel. It should be pointed out that the criteria listed in Table 3 are the values at which objects are sufficiently contaminated to be considered hazardous materials. The seven samples listed were effectively over 100 times higher than these limits.

Lead was not the only contaminant of concern. Other metals were also found to be well above acceptable limits. Samples FR-10, FR-17, FR-18, FR-21, FR-22 and FR-35 also showed very high concentrations of barium, up to 30 times acceptable values. High levels of cadmium showed up in 4 samples, FR-3, FR-10, FR-17 and FR-20, the latter being nearly 10 times above the government standard. FR-1 showed elevated levels of chromium.

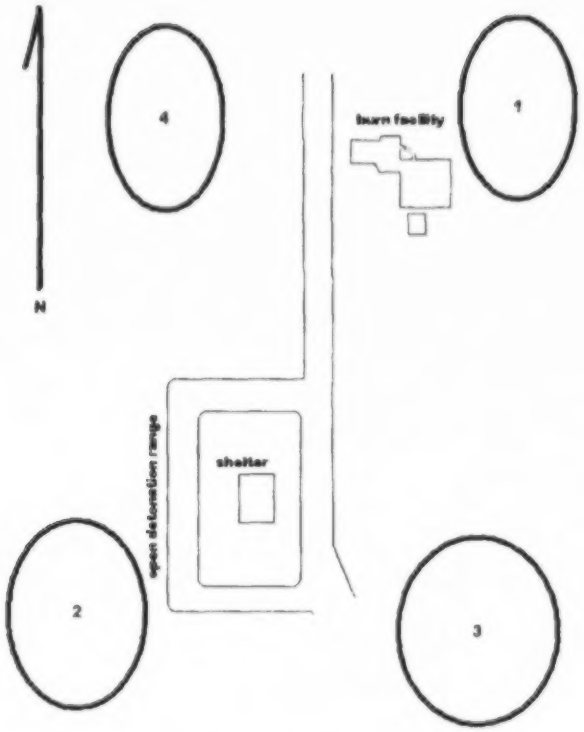
Figure 7. Foliage sampling locations

Four representative foliage samples were obtained by compositing. Each sample of grass leaves and stems was collected randomly over a 0.5 km^2 area. The four samples were collected in one of four broad locations, located to the northeast, northwest, southeast and southwest of the burn facility and shelter. These locations may be seen in Fig 7. The sample to the NE was collected on the large earthen berm located at the site. A compositing approach was used and a minimum of 20 discrete samples were collected randomly over the 0.5 km^2 area. The foliage samples were each approximately 1 kg total, and were stored in several large polyethylene bags. Samples were frozen and sent to the lab where they were totally digested prior to analysis.

The results of the four composite foliage samples seem, initially, to be acceptable. Annex 4 lists the analytical results from the foliage samples. Lead concentrations are quite low when compared to most of the soil samples. However, considering that Bisessar and McIlveen [16,17] determined that terrestrial plant uptake of lead was 1-8% of the soil concentrations, even these low values are of concern. They become more alarming when one considers that Fleming found little lead migration to aboveground plant tissues – most lead remained concentrated in the roots. The foliage samples taken in this study were exclusively aboveground – stems and leaves. No roots were sampled. Strontium, barium, and boron were also found at levels that may be cause for concern, although no published criteria exist for the presence of these elements in terrestrial plants.
